Hardison Residence

Leicester, NC

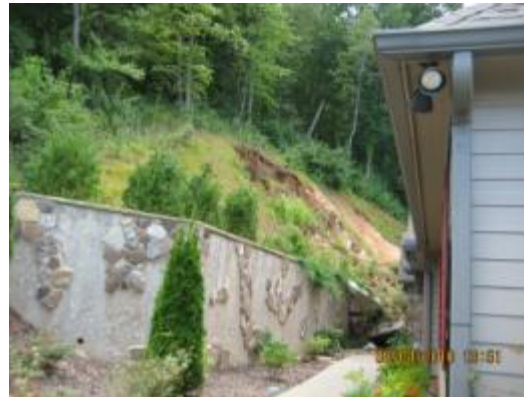
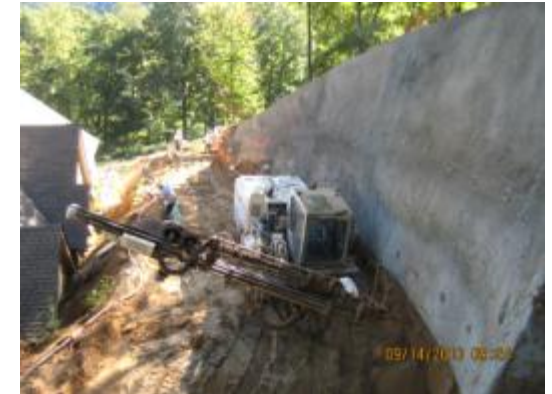
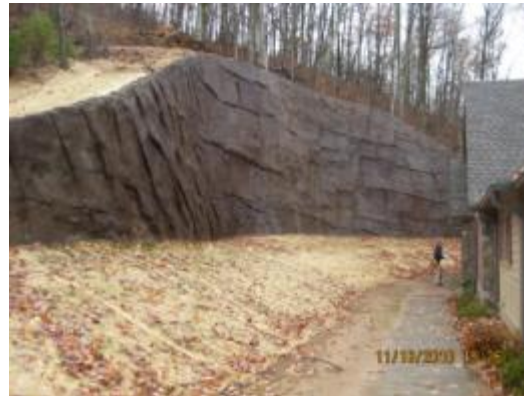
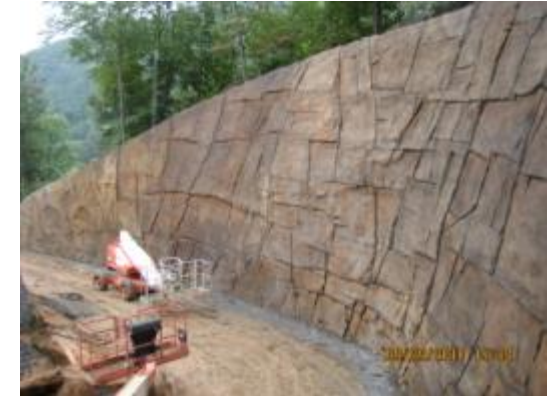
A single family residence was constructed at the toe a soil cut slope inclined at approximately 1H:1V . The soil slope failed and caused a portion of a retaining wall at the toe to collapse, causing damage to the residence.

A soil nail wall was constructed to allow removal of the cast-in-place wall and stabilize the slope. A sculpted and stained finish was applied to blend the retaining wall into the hillside.
