# Rice White Building

Asheville, NC

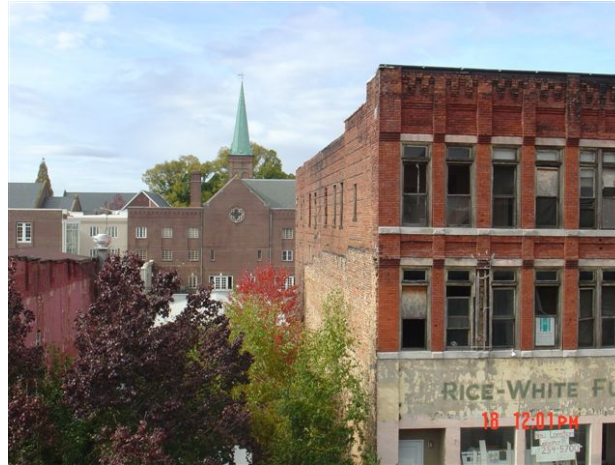
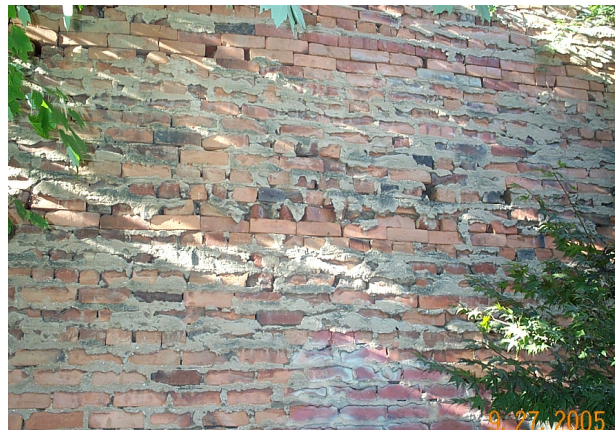
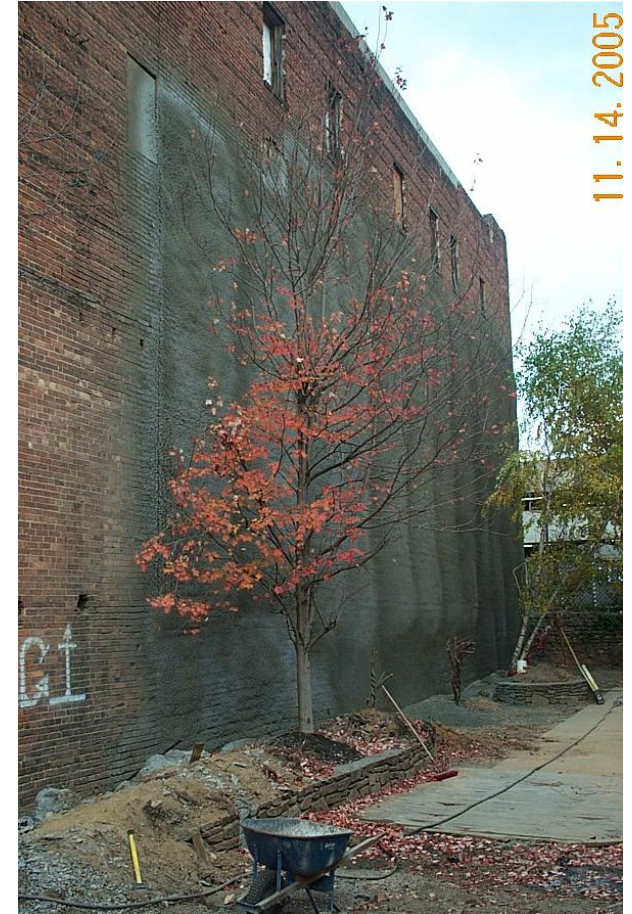
The Rice White Building, located at 19 Biltmore Ave. was being renovated for office/retail development. The south side of the structure was in poor condition due to weathering of the brick and mortar joints.

An approximately 2" thick layer of lightly reinforced, [wet mix shotcrete](#) was placed over the exposed south wall to protect the brick from further weathering damage.
